TOWNSHIP OF AMELIASBURGH

A Survey of

FENWOOD GARDENS WATER WORKS SYSTEM

1972

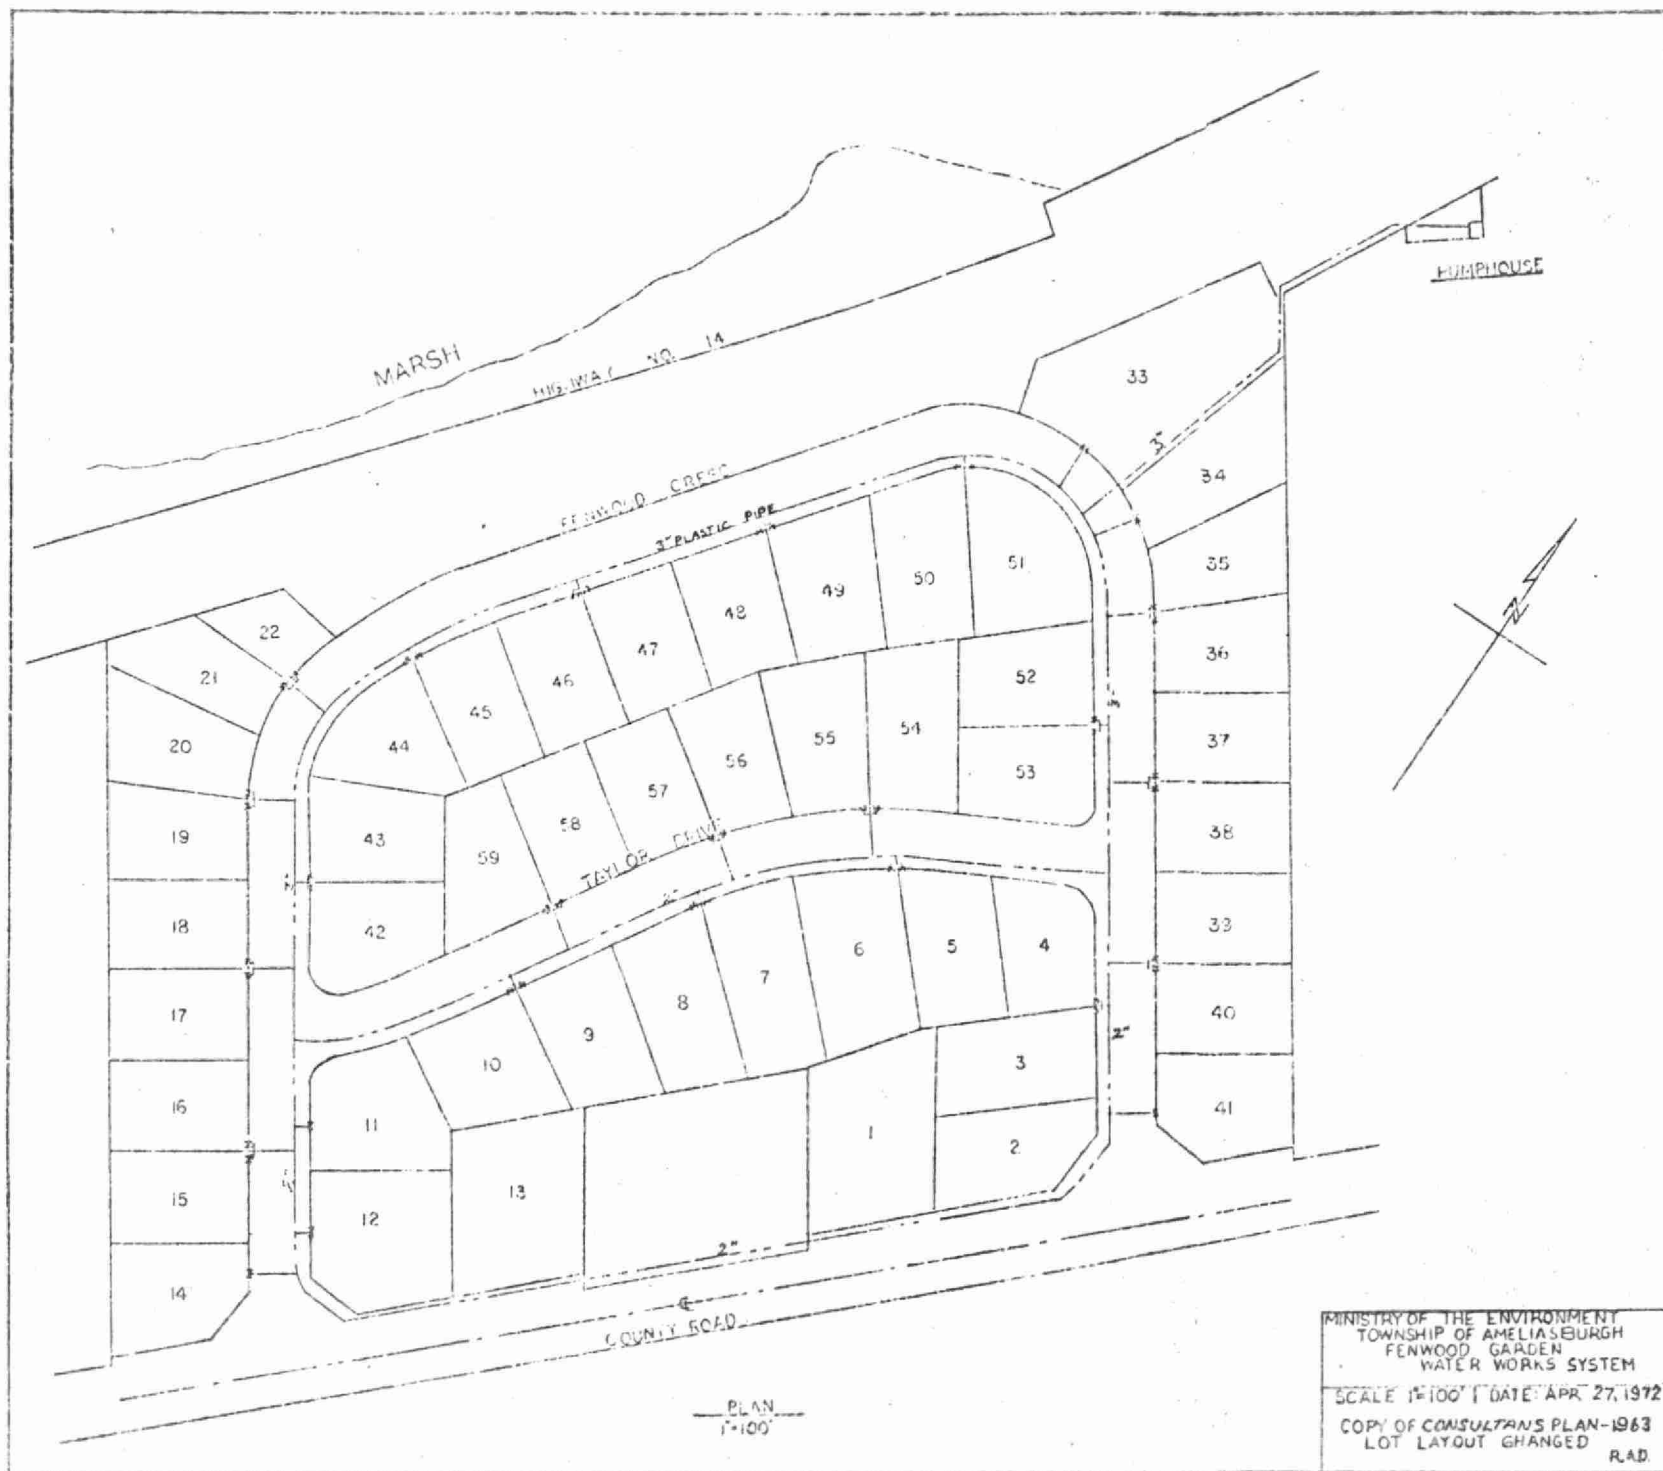
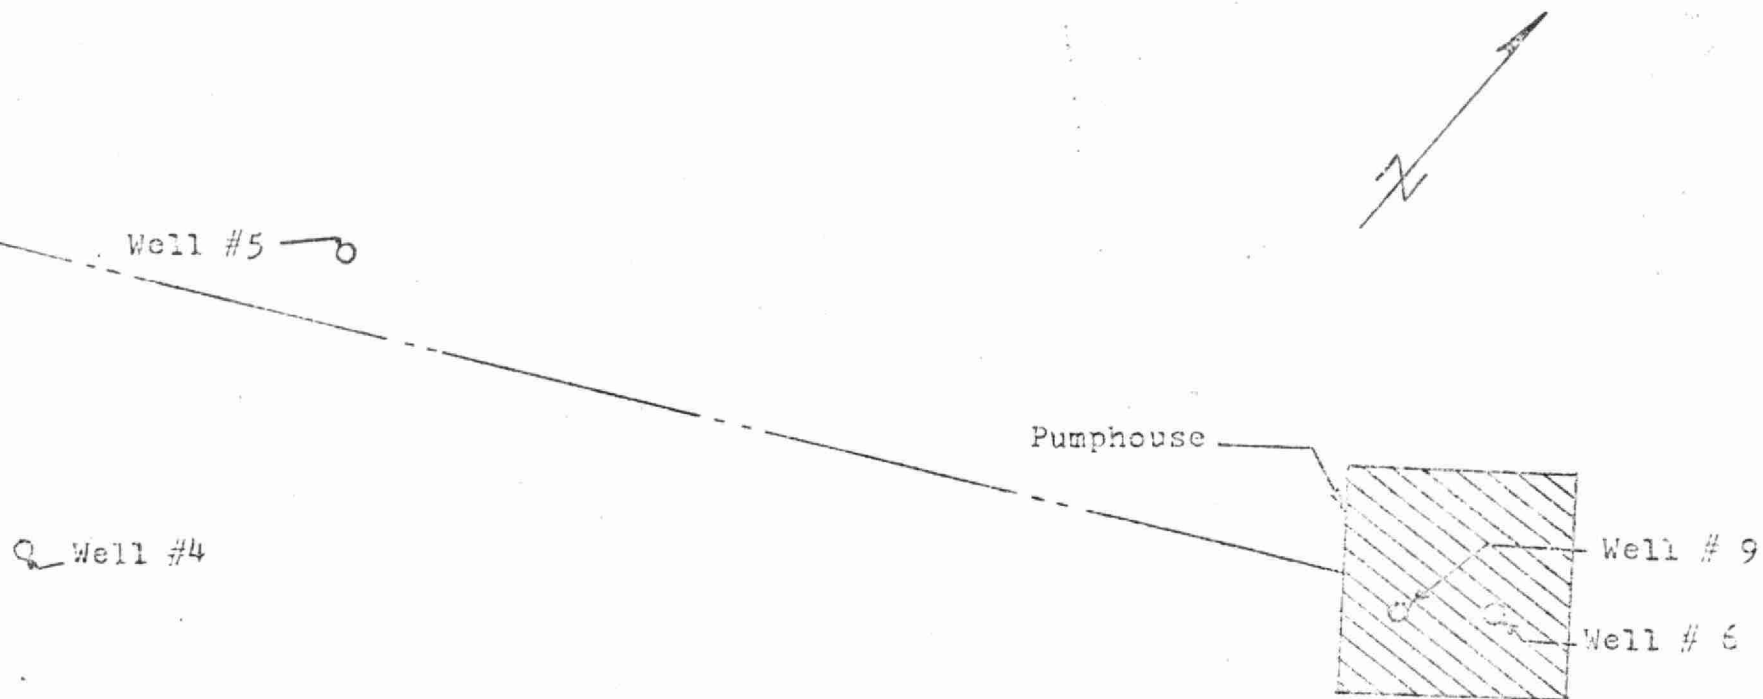
Water System for Subdivision
of Part of Lot 66 Conc 2
Township of Ameliasburgh
Pumphouse Site Plan

Certain changes had to be made to the original plumbing and piping in the pumphouse to provide ideal chemical dosing points. The system uses Well pumps # 6 and # 9 to provide water to the subdivision while pump # 4 is used on a standby basis at this time. (Pump numbers correspond to the well number). Discharge lines from Wells # 6 and # 9 join in a "Y" connection and form a common line into which the two chemicals, sodium silicate (SiO_2) and sodium hypochlorite (NaO Cl) are added.

Well # 4 has a separate line which joins in the main line by means of a "T" connection which directly proceeds the water meter. As the system now exists, all water from Wells # 6 and # 9 will be subject to the addition of chlorine and silica. The water from # 3 well, used on a standby basis, will be mixed with the water from the other two wells and although the concentration of the chemicals being added will be reduced on a concentration basis, no oxidation and/or settling of iron should occur. The actual dosage in mg/l of Si O_2 has not been determined due to the shortness of time, priority of the project and the number of problems encountered. This dosage will be determined by checking the results of samples taken. The chlorine dosage is sufficient to provide a residual of 0.3 to 0.5 mg/l leaving the pumphouse.

9. Plumbing changes should be made at the pumphouse to ensure that discharge water from Well # 4 enters the same line as does the discharge water from Wells # 6 and # 9 in order to provide silicate and chlorine addition to all water in a pre-pressure tank position.
